ARMY ENGINEER WATERWAYS EXPERIMENT STATION VICKSBURG--ETC F/G 8/6  
ENGINEERING GEOLOGY AND GEOMORPHOLOGY OF STREAMBANK EROSION. RE--ETC(U)  
OCT 81 C B WHITTEN, D M PATRICK

4. TITLE (and Subtitle) ENGINEERING GEOLOGY AND GEOMORPHOLOGY OF STREAM- BANK EROSION; Report 2, YAZOO RIVER BASIN UPLANDS, MISSISSIPPI	5. TYPE OF REPORT & PERIOD COVERED Report 2 of a series

7. AUTHOR(s) Charlie B. Whitten David M. Patrick	6. PERFORMING ORG. REPORT NUMBER Jun 77 - Aug 78	
9. PERFORMING ORGANIZATION NAME AND ADDRESS U. S. Army Engineer Waterways Experiment Station Geotechnical Laboratory P. O. Box 631, Vicksburg, Miss. 39180	8. CONTRACT OR GRANT NUMBER(s)

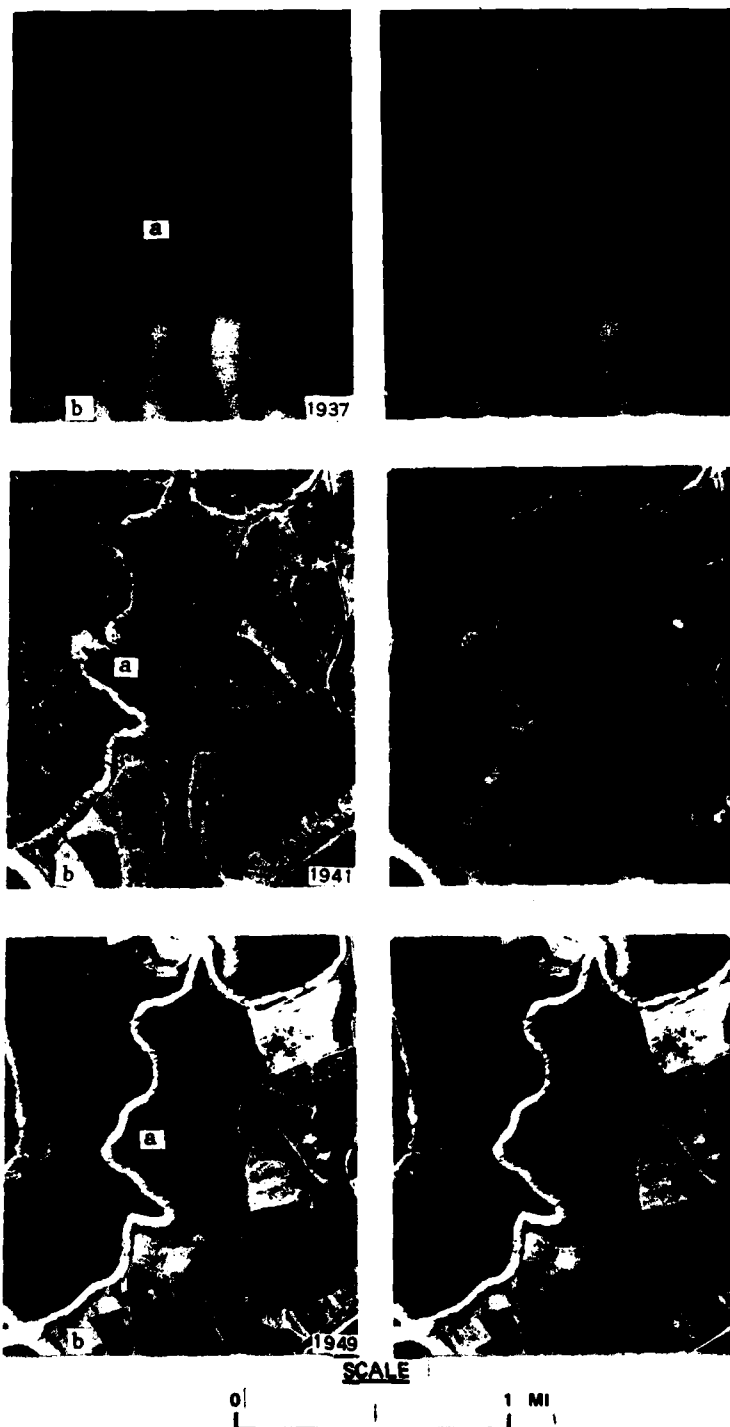
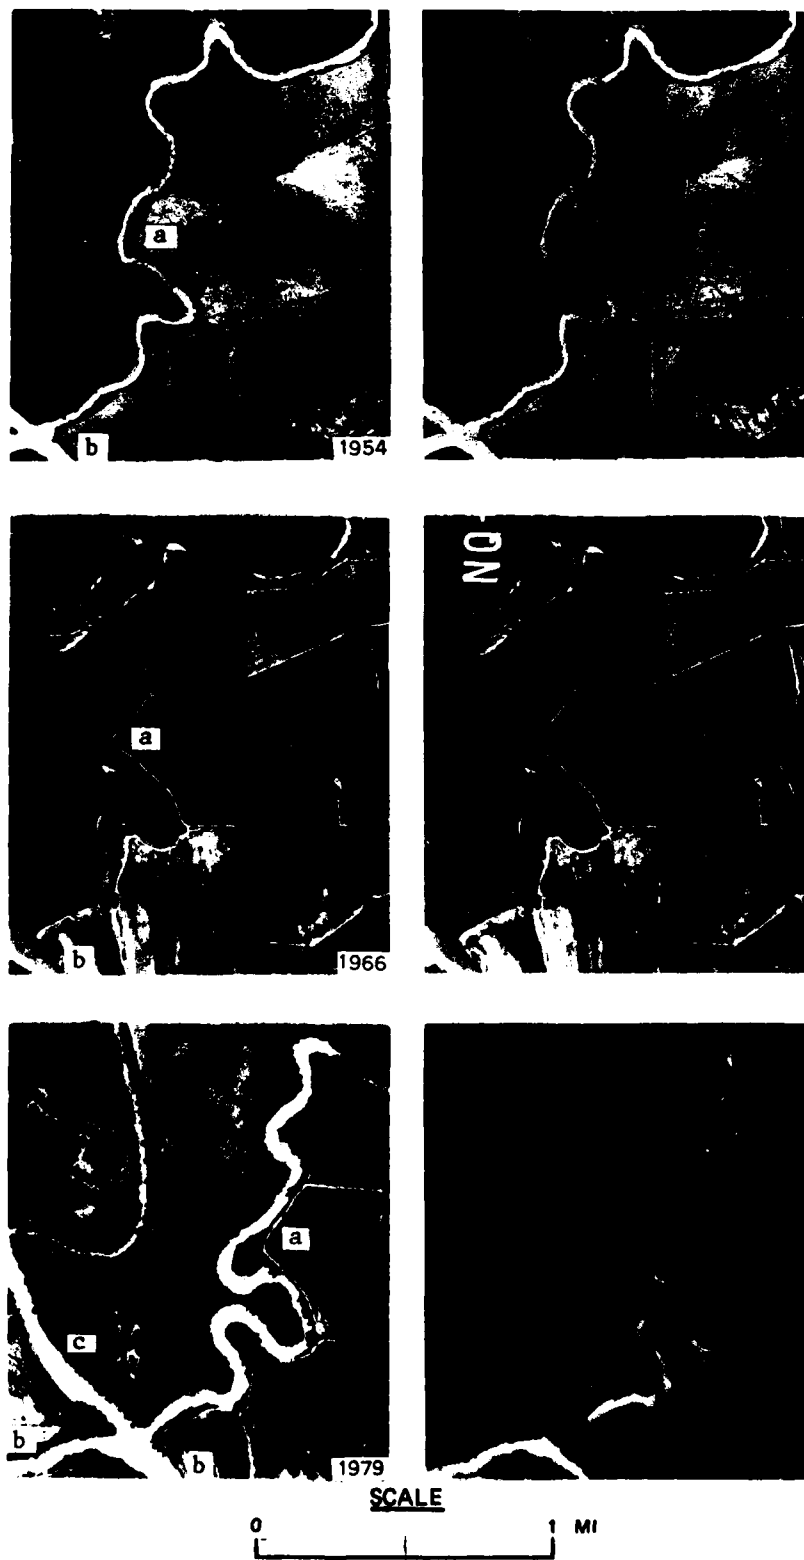
57. Site T1 is located at the mouth of Tillatoba Creek and includes approximately 1 mile of the channel (Figure 14). This section of Tillatoba Creek was not channelized. Channel width doubled from 1937-79. The increase in width occurred at a uniform rate, rather than having one short period of rapid bank erosion. The smaller meander loops were cut away, while the larger meander loops have not been extensively altered, except for the meander loop at the mouth. This meander loop has been gradually eroded into a very tight loop, which will probably be cut off in the near future.

Figure 14. Site T1 on Tillatoba Creek (Symbol "a" designates Tillatoba Creek; "b" is Tallahatchie River, and "c" is the Panola-Quitman Floodway; see 1979 photos.) (Continued)

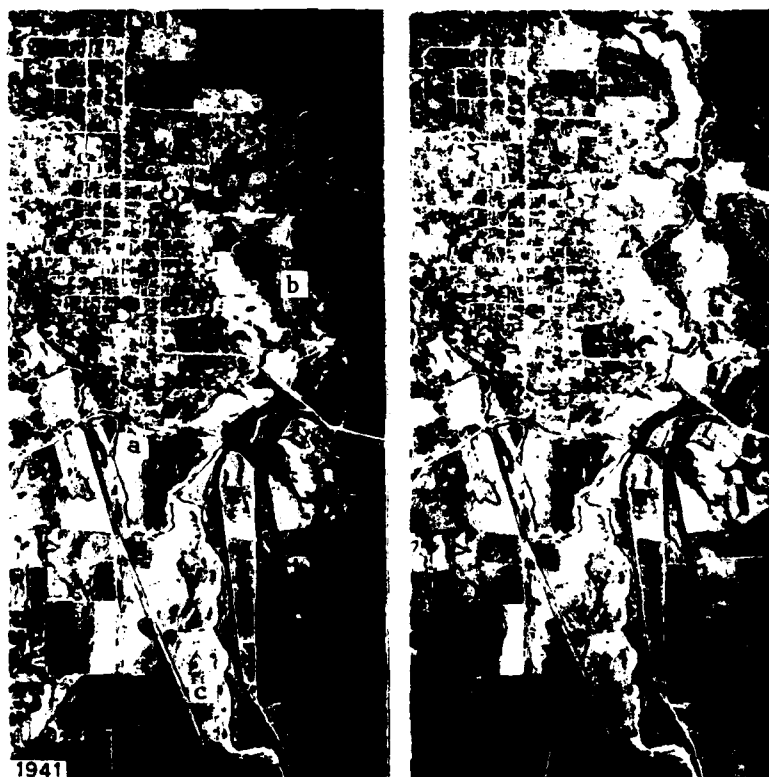
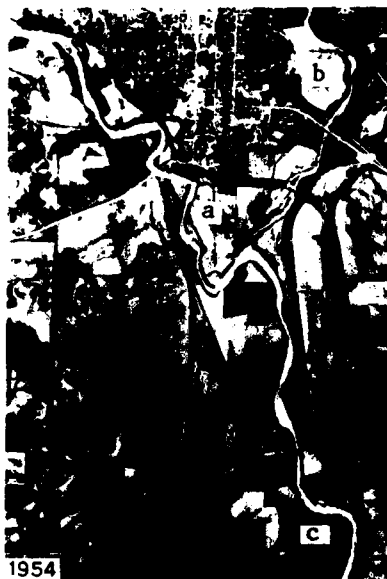
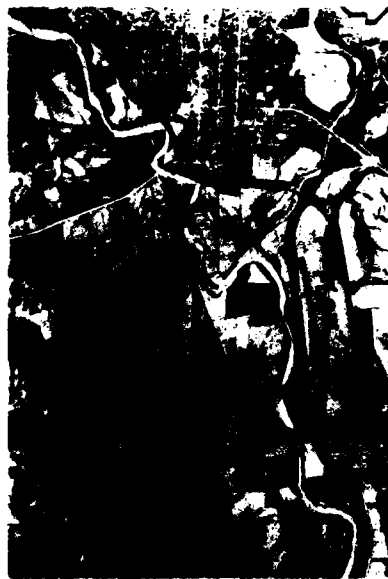
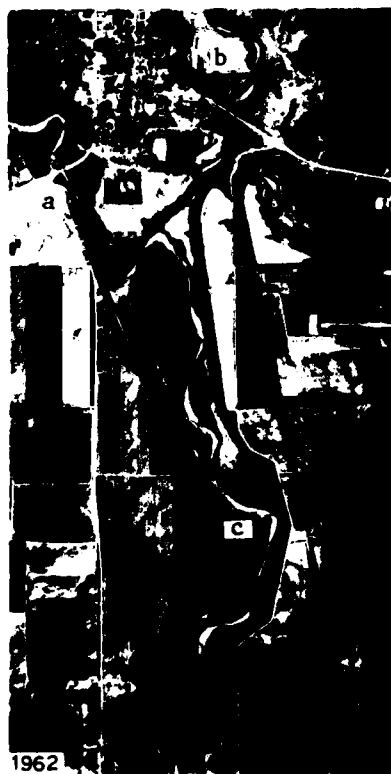
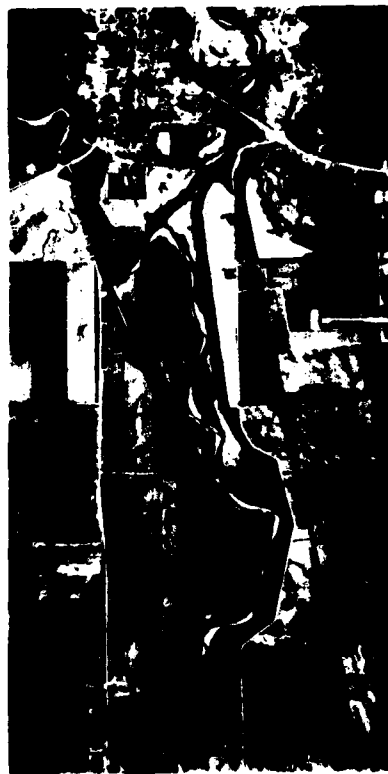
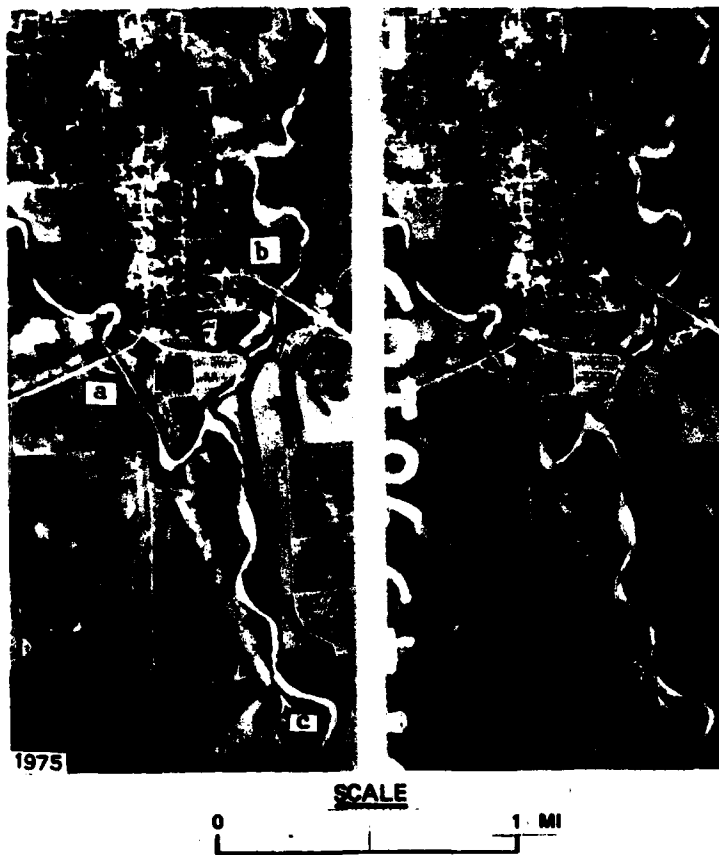
Figure 15. Site T2 in Tillatoba Creek Basin (Symbol "a" designates the North Fork, "b" is South Fork, and "c" is Tillatoba Creek (Sheet 1 of 3))

North Fork, and South Fork (Figure 15). No observable erosion occurred on the vegetation-covered 1937 channels. Tillatoba Creek and a short reach of North and South Forks at the mouths had more than doubled in width by 1941. The banks in this area appeared as raw fresh cuts that were being actively eroded. Frequent slumps and cave-ins in the upper stretch at site T2 indicate bank erosion was very active there in 1941. The channel width of North and South Forks had not increased significantly from 1937 to 1941. The hanging tributaries indicate channel degradation had been or was still active in 1941. Point bars were better developed and more numerous in the lower stretch of site T2.

59. Bank erosion had increased the 1954 channel width of all three channels at site T2 to double that of 1937, and the banks were still eroding in 1954, especially the outside banks of the meanders. Channel widths have continued to increase since 1954. The increases in channel widths since 1954 have not been as extensive as the 1937-54 increases. Isolated stretches of previous streambeds at higher elevations than present streambeds and hanging tributaries indicate the channels have degraded. Point bars were numerous and well developed in all channels from 1954 to present. The thalweg meandered in the wider channels, eroding the banks where it was deflected against the banks by point bars.

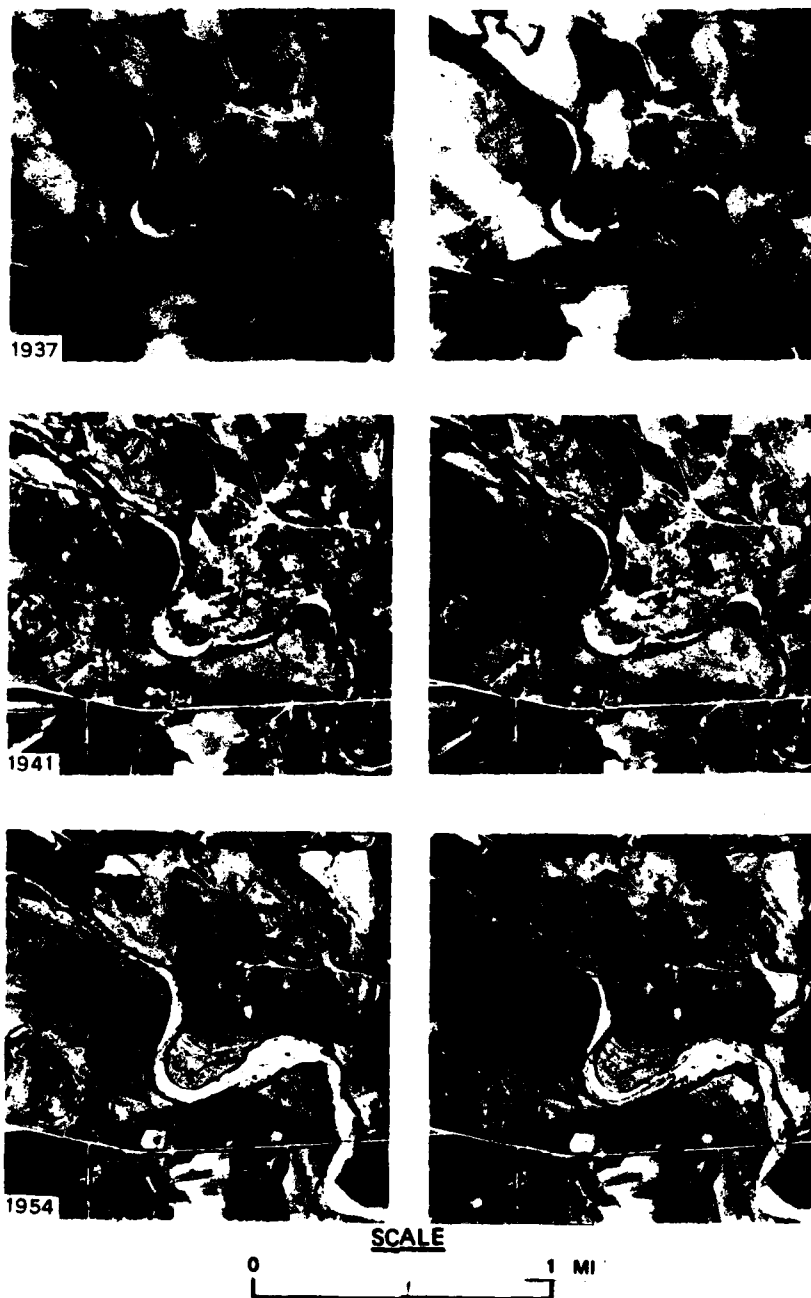
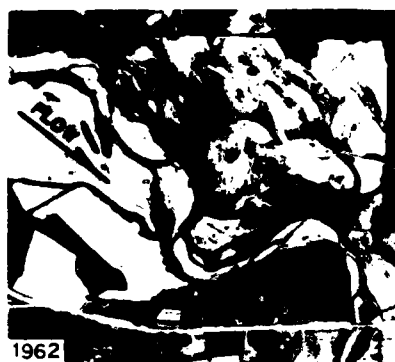
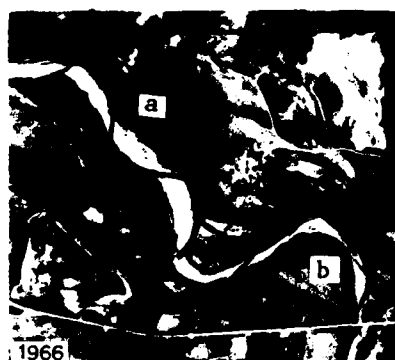
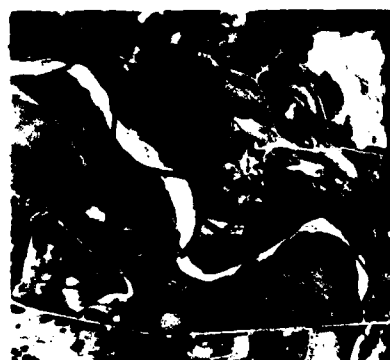
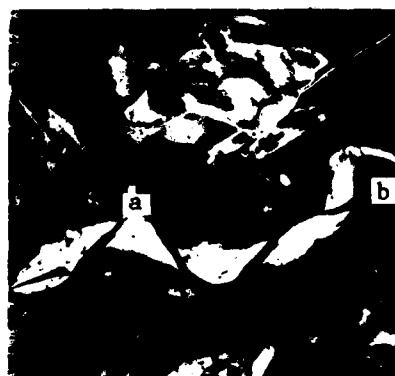
Figure 16. Site T3 in Tillatoba Creek Basin, North Fork (Continued)

60. Site T3 is located on North Fork, 3.9 miles (1962 stream distance) upstream from the mouth of North Fork and includes approximately one-half mile of the channel (Figure 16). The only detectable bank erosion in the 1937 channel was occurring on the outside banks of meander loops. No significant observable changes occurred in channel dimensions by 1941. The generally ragged appearance of the channel indicates the channel had been or was being eroded. The channel width in the lower stretch of site T3 had more than tripled by 1954, and the banks in the upper stretch were being very actively eroded. The extremely rapid rate of bank erosion at T3 can be seen by comparison of the 1941, 1954, 1962, 1966, and 1976 aerial photographs (Figure 16). Bank width increased 283 percent from 1941-76. The wide channels had large, well-developed point bars. The thalweg was meandering in wide sediment-filled channels,

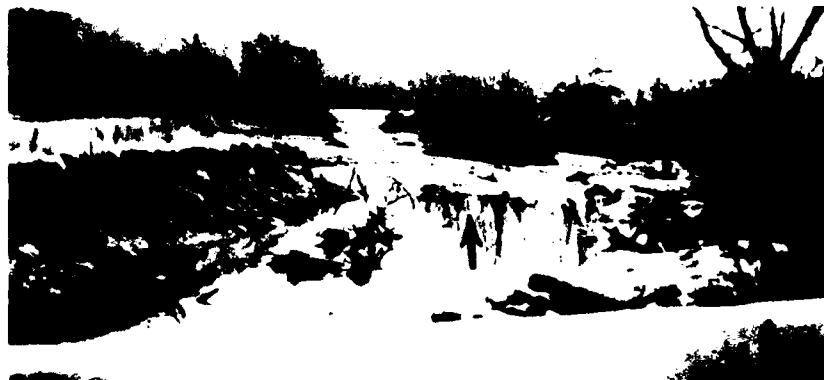
61. Site T4 is located on North Fork at the mouth of Sandy Creek, 8.3 miles (1962 stream distance) above the mouth of North Fork and includes approximately 1 mile of the North Fork channel (Figure 17). The erosional effects of the large sediment loads from upland erosion were more noticeable on the North Fork channel and its tributaries in the upper reaches of the North Fork Basin. North Fork and Sandy Creek channels appeared entrenched in 1937. The banks were steep and vertical with numerous gullies cutting into them. The smaller drainages had hanging channels. The channel width of North Fork and Sandy Creek decreased from 1937-79. The quantity of sediments in the channels also appears to have decreased with time. The 1937-41 channel appears to have been entrenched in an older channel that was two to three times wider than the 1941 channel. North Fork channel is presently being rapidly eroded approximately 2 miles downstream from site T4 and appears stable 1 mile upstream from T4 (Figure 18).

Figure 18. North Fork channel (Symbol "a" is a stable channel, "b" is an unstable channel, and "c" shows several feet of bank erosion that occurred from Sep 1977 to Feb 1980; the lower grade-control structure on North Fork can be seen in the background of "b" and "c.")

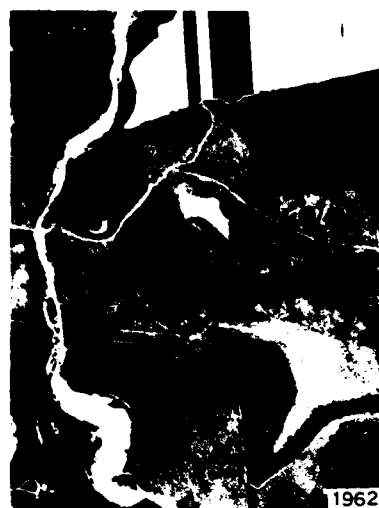
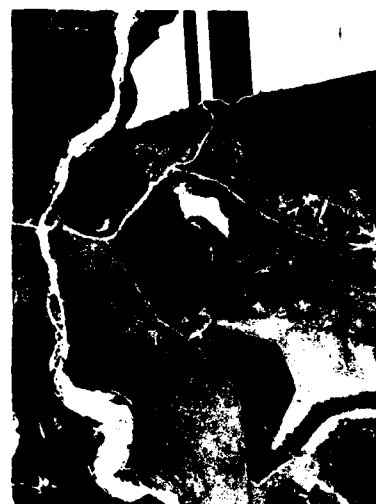
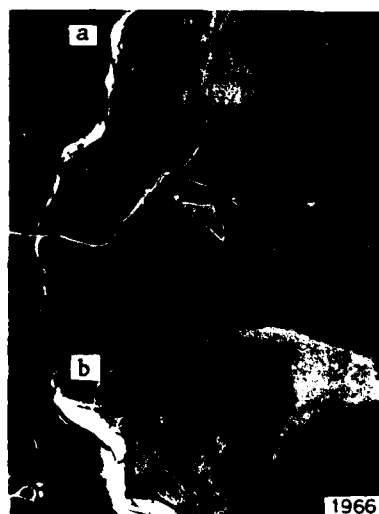
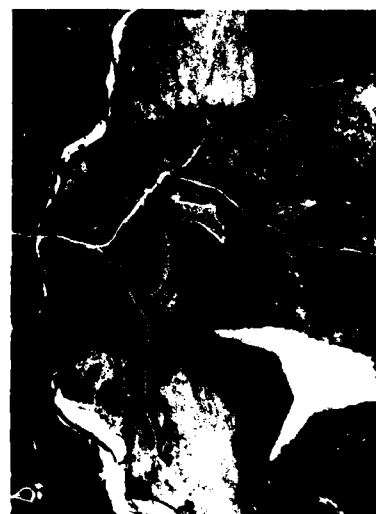
Figure 19. (Concluded)

62. Site T5 is located on South Fork, 5.8 miles (1954 stream distance) upstream from the mouth of South Fork and includes approximately one-half mile of the channel (Figure 19). The 1937 channel was lined with vegetative growth. No observable channel erosion is seen in the photos. The 1941 channel is slightly wider than the 1937 channel. Judging from the rough fresh cut appearance of the banks, bank erosion was very active. Hanging tributaries were being eroded near the tributary mouths. The channel width of South Fork more than doubled from 1941-54. A very significant increase in channel depth occurred. The increase in vegetative debris, absence of point bars, decrease in channel width, rough appearance in the upper stretch of the channel, and irregular shape of the point bars in the lower stretch indicate the upper stretch was being very actively degraded. The meander loop in the lower stretch was cut off by man during the early 1950's. The channel has continued to widen and deepen since 1954, but not as rapidly as during the 1941-54 period. The elevation differences between the bed of the cutoff meander loop and subsequent channel beds indicates the

channel is degrading. Bank erosion has cut away the meander loops in the channel, thereby shortening the channel.

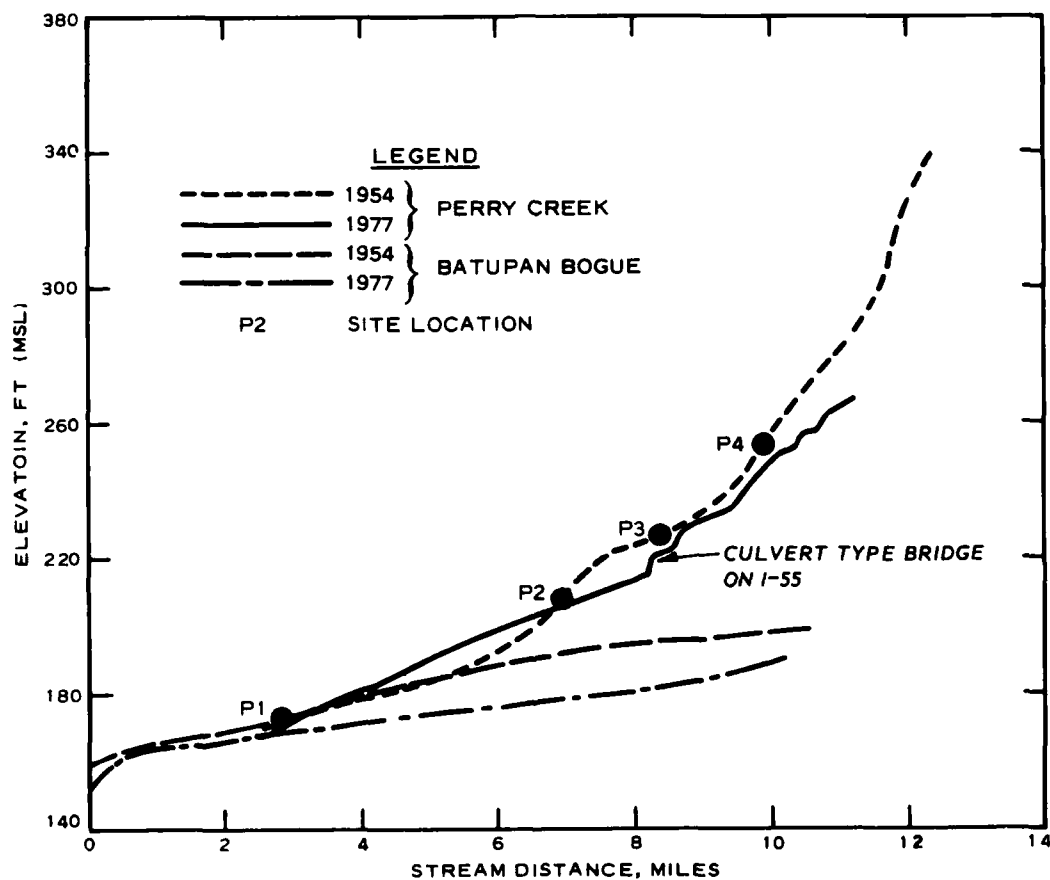
80. The chronological sequences of aerial photographs of each of the four sites of Perry Creek show there has been a very significant increase in channel depth and width since 1935 and that these increases have advanced upstream with time. The knickpoint on the 1954 longitudinal profile is located between sites P2 and P3 (Figure 43). Interstate Highway 55 bridge, built at site P3 in 1965, acted as a grade-control structure, preventing any further degradation from advancing past this point after 1965. The prominent knickpoint on the 1977 longitudinal profile shows the effectiveness of this culvert-type bridge as a grade-control structure. The channel downstream from the culvert had degraded 6 to 8 ft by 1977 (Figure 44). The banks are steep with frequent cave-ins, slumps, and undercut trees. The channel directly upstream from the bridge appears stable (Figure 44). Cross sections of Perry Creek show bank erosion has been more extensive downstream from the bridge than upstream (Figure 45).

Figure 43. Longitudinal profiles of Perry Creek and Batupan Bogue (1954 data from USGS Topographic maps; 1977 data from Corps of Engineers survey; sites P1 through P4 are located on the 1954 profile.)

151. Perry Creek flows into Batupan Bogue approximately 2 miles downstream from the junction of Batupan Bogue and the Yalobusha River. Longitudinal profiles and cross sections show the Yalobusha River has degraded. Figure 88 shows the Yalobusha River degraded 5-6 ft from 1951-53. Batupan Bogue has attempted to degrade in response to the lowering of its base level, which is the Yalobusha River. The 1954 and 1977 longitudinal profiles of Batupan Bogue show a knickpoint at the mouth (see Figure 43). The knickpoint is evidently hung up on a hard

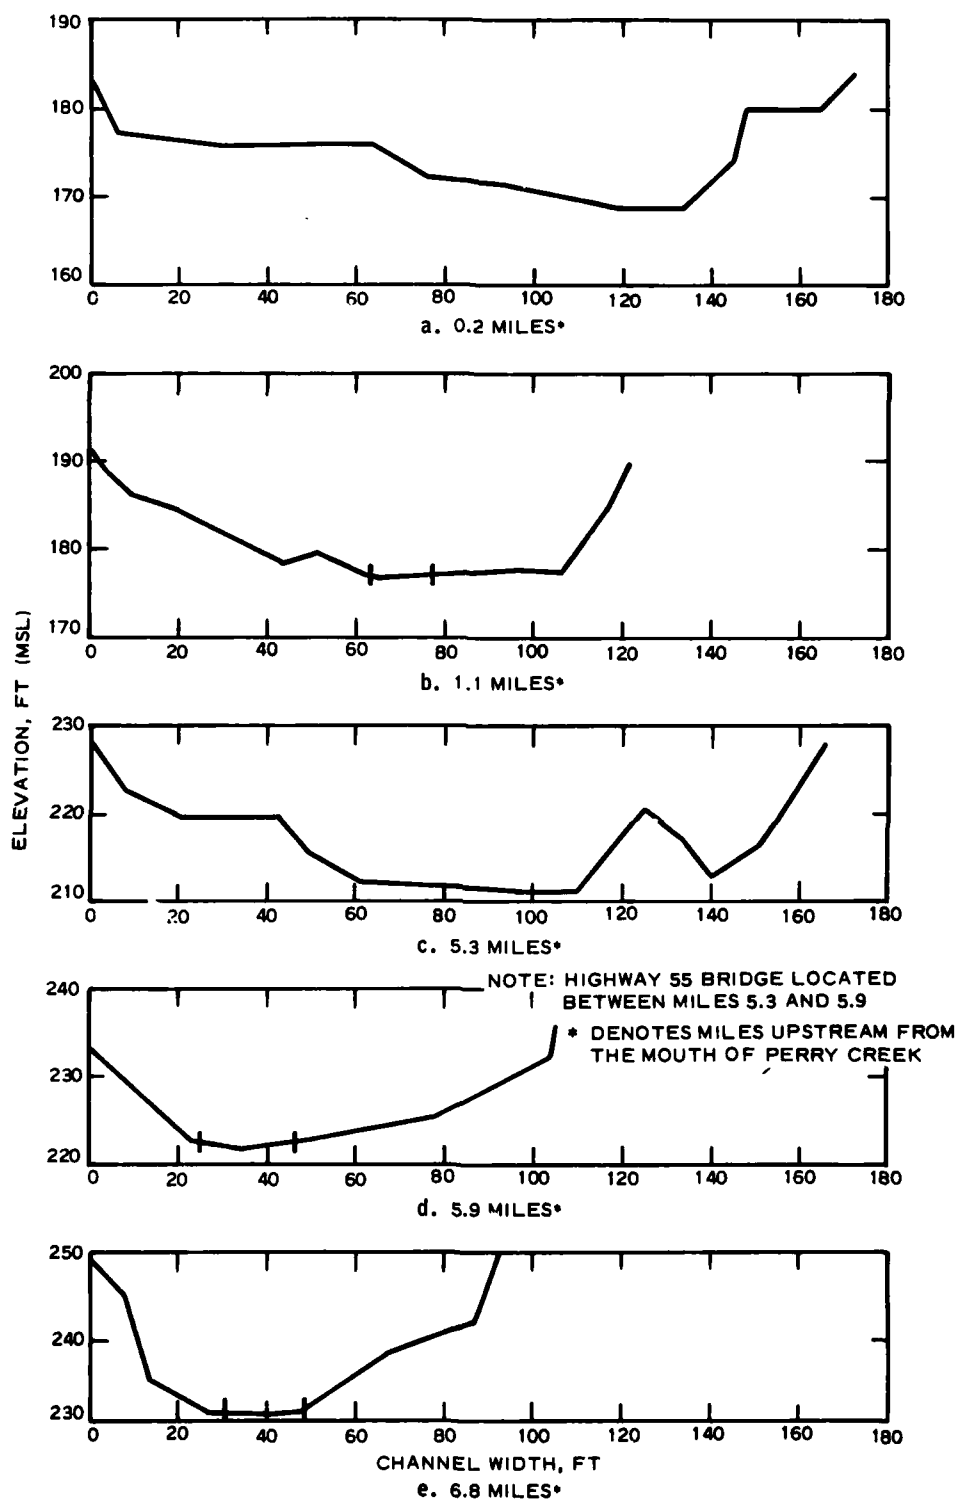
Figure 45. Cross sections of Perry Creek in 1977 (from Corps of Engineers survey data)

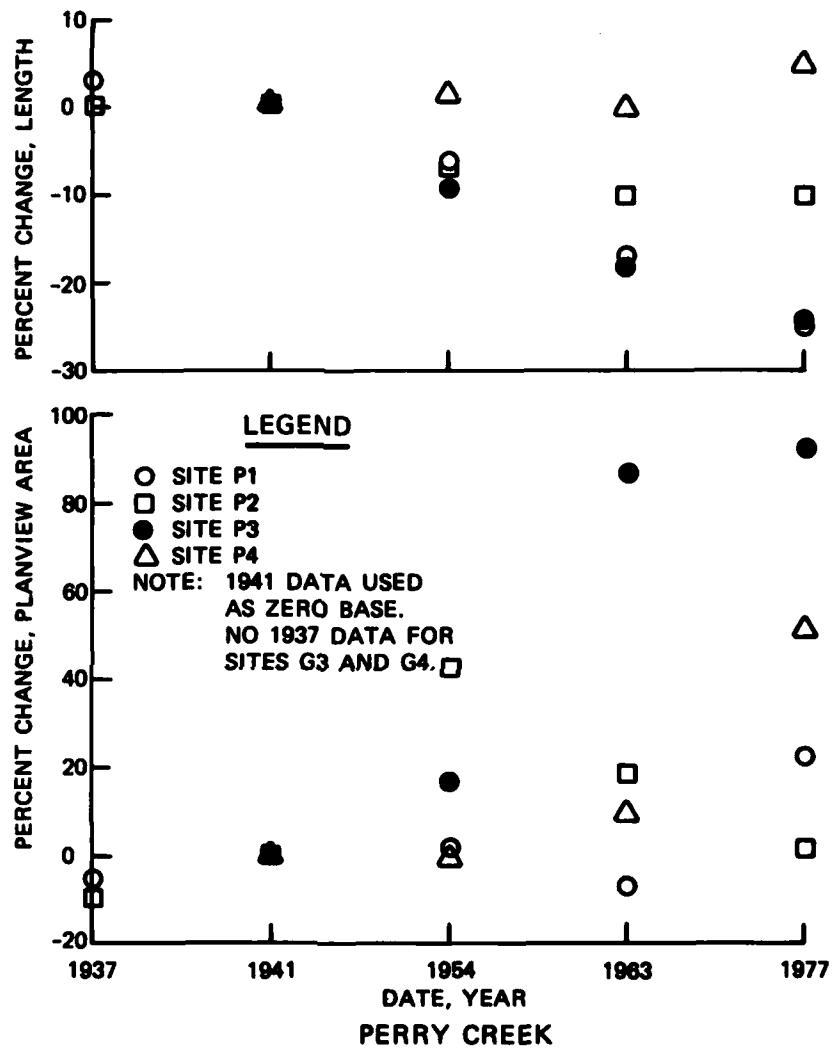
81. Figure 46 shows the changes in channel area and length at each of the four sites since 1937. There has been a general decrease in channel length at all the sites, except for P4, which has changed very little. Bank erosion cut away the meander loops and bends, thereby straightening and shortening the channel. Figure 47 shows the decreases

Figure 46. Changes in planform area and channel length of Perry Creek

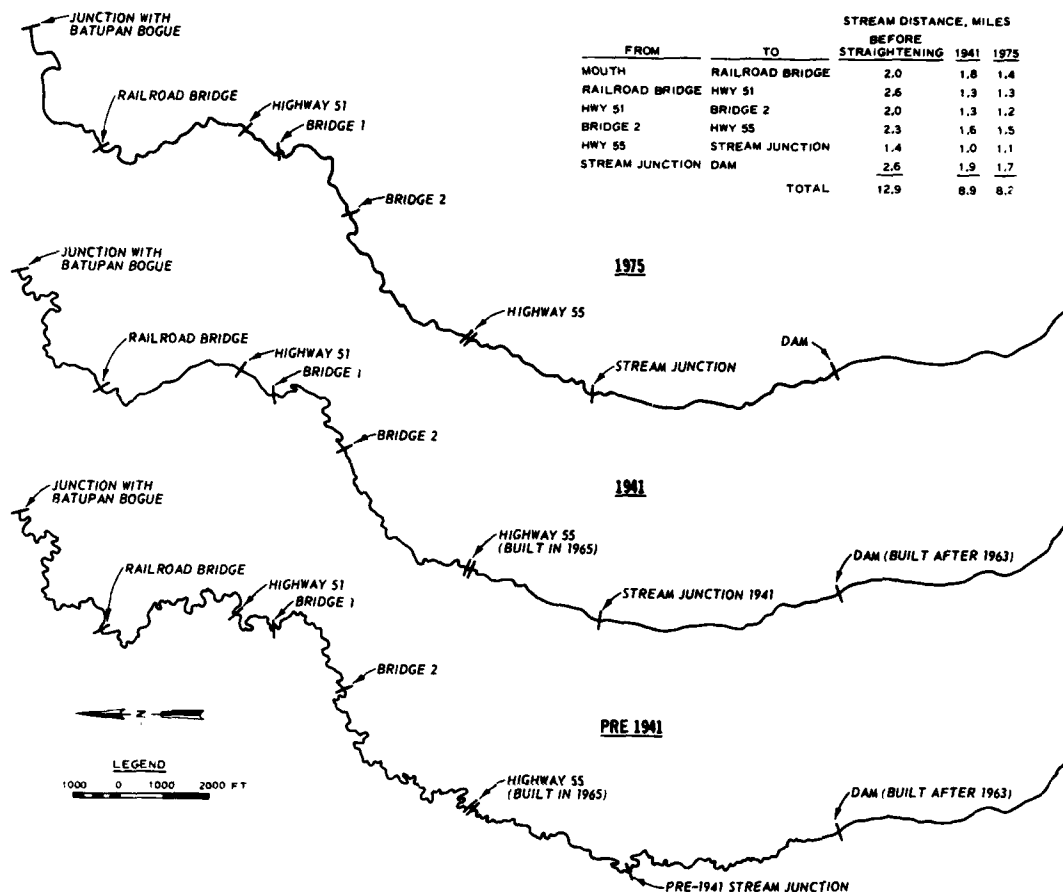
Figure 47. Changes in the channel length of Perry Creek in channel length from pre-1941-75. Channel area either increased or decreased as the channel was widened. The combination of channel widening and shortening determined whether there was increase in channel area. Channel area increased at site P4 as the length decreased, while just the opposite effect occurred at site P2.

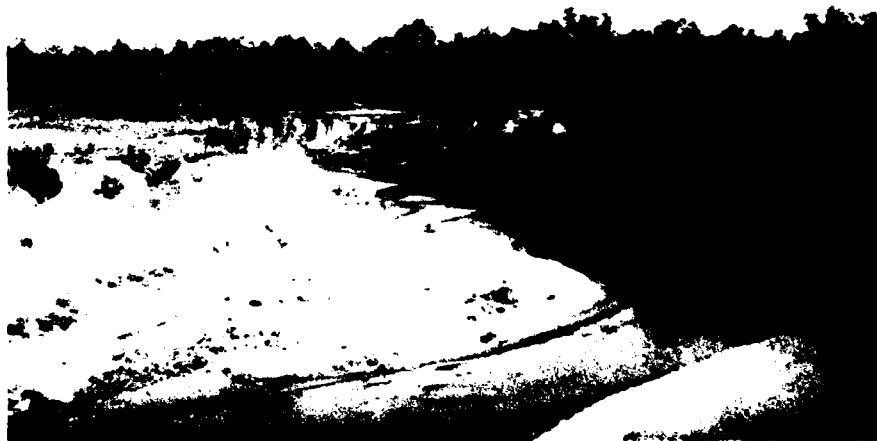
95. The modern Hotopha Creek channel is characterized by vertical or nearly vertical banks that are 15 to 20 ft high, frequent cave-ins or slumps, a rapid decrease in bed load in the upstream direction, deposition of relatively large quantities of sediment in the lower reaches of the channel, and Quaternary clays exposed in the bed of the middle and upper reaches of the channel (Figure 58).

b. Lower reach

Figure 58. Upper and lower reaches of Hotopha Creek

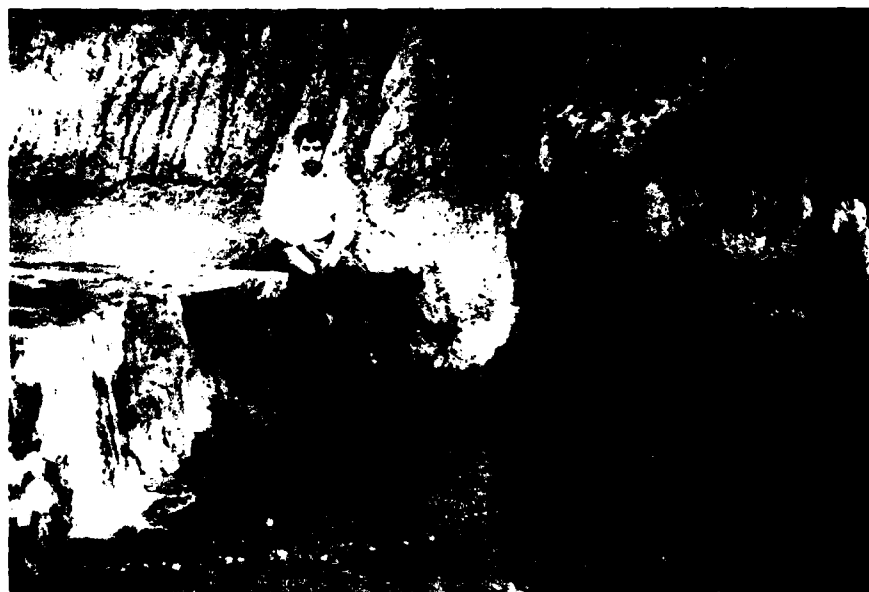
b. Close-up

Figure 63. Knickpoint at site H4 on Hotopha Creek, 1978 (See symbol "A" on the 1977 photograph in Figures 62 and 65.)

105. There is a very prominent knickpoint at point A on the 1976 longitudinal profile (Figure 65). The knickpoint is cutting an erosion-resistant clay and has formed a 4- to 5-ft waterfall (Figure 63). The steep, unstable banks resulting from the channel degradation are slumping or caving in. The channel directly downstream from the knickpoint is 6 to 10 ft wider than the channel directly upstream from the knickpoint. Cross sections of the 1961 and 1976 channels show there is a downstream increase in width and an upstream increase in depth (Figure 67). The downstream increase in width results from the slumping and caving of the oversteepened banks and from bank erosion caused by the increased sediment load. The banks are also being eroded by piping (Figure 68).

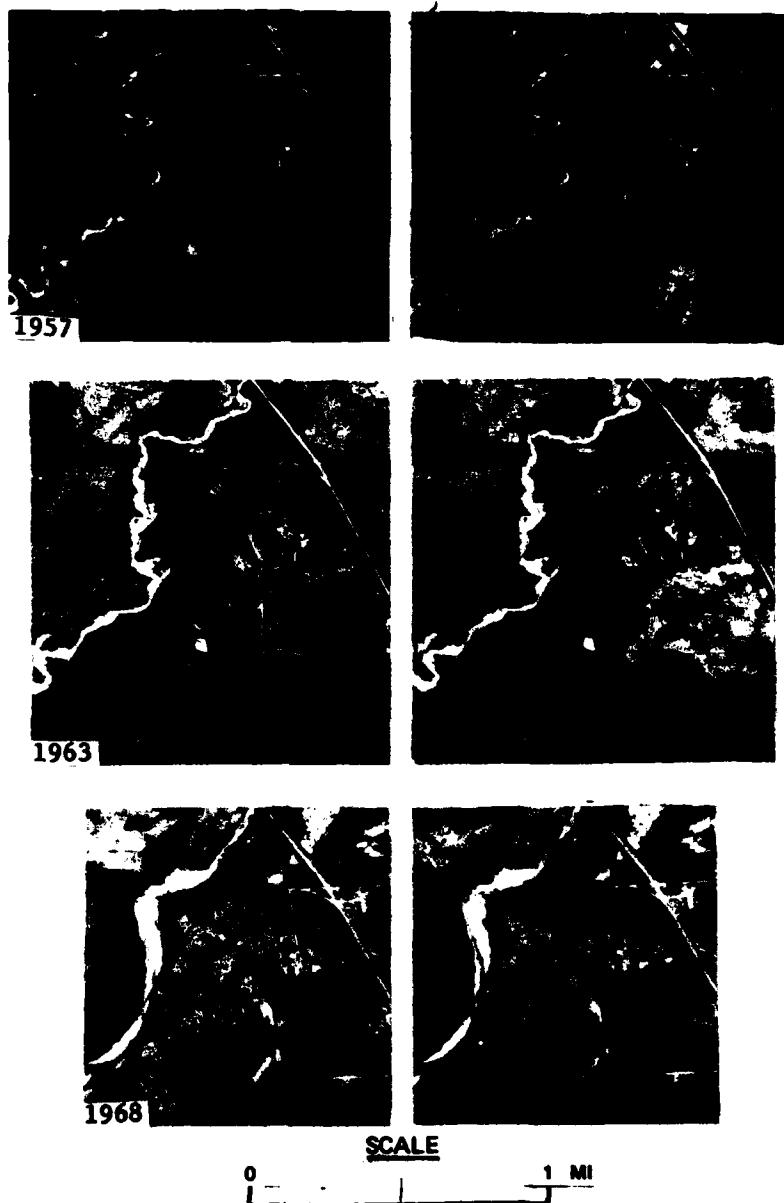
gradient in the channelized stretch was increased from about 7.8 ft/mile to 11.1 ft/mile. A comparison of the 1961 and 1976 longitudinal profiles shows the channel has degraded up to 15 ft (Figure 65). The degradation was caused by the continued upstream advance of the knickpoint shown on the 1953 longitudinal profile and of subsequent knickpoints. The increased gradient in the channelized section probably increased the rate of speed of upstream movement of the knickpoint. Figure 66 shows the stretch of Hotopha Creek between sites H1 and H2. The knickpoint was approaching the lower part of site H2 in 1957. The channel in Figure 66 had nearly tripled in width by 1968.

Figure 66. Hotopha Creek between sites H1 and H2 (Site H2 is directly upstream.)

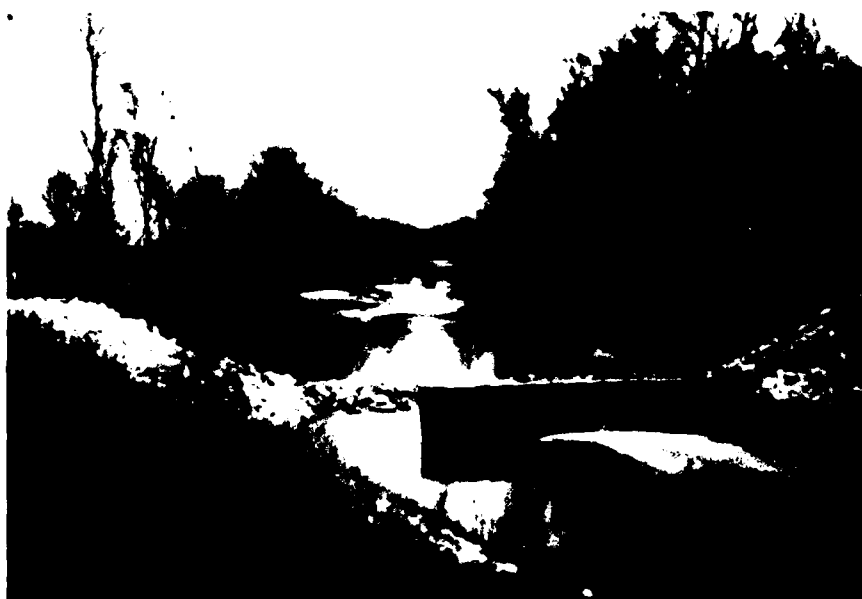
a. Lower structure in North Fork, 4-ft drop

Figure 70. Two grade-control structures in  
Tillatoba Creek Basin

accompanying bank erosion. Figure 70 shows two of the grade-control structures constructed in Tillatoba Creek Basin.

108. The effectiveness of the channel erosion control methods has not yet been determined as of this date. The substantial increases observed in channel width as a knickpoint advances upstream, especially where the knickpoint is retarded by erosion-resistant materials, such as clay or a limonitic ledge suggest that there could be problems in maintaining some grade-control structures.

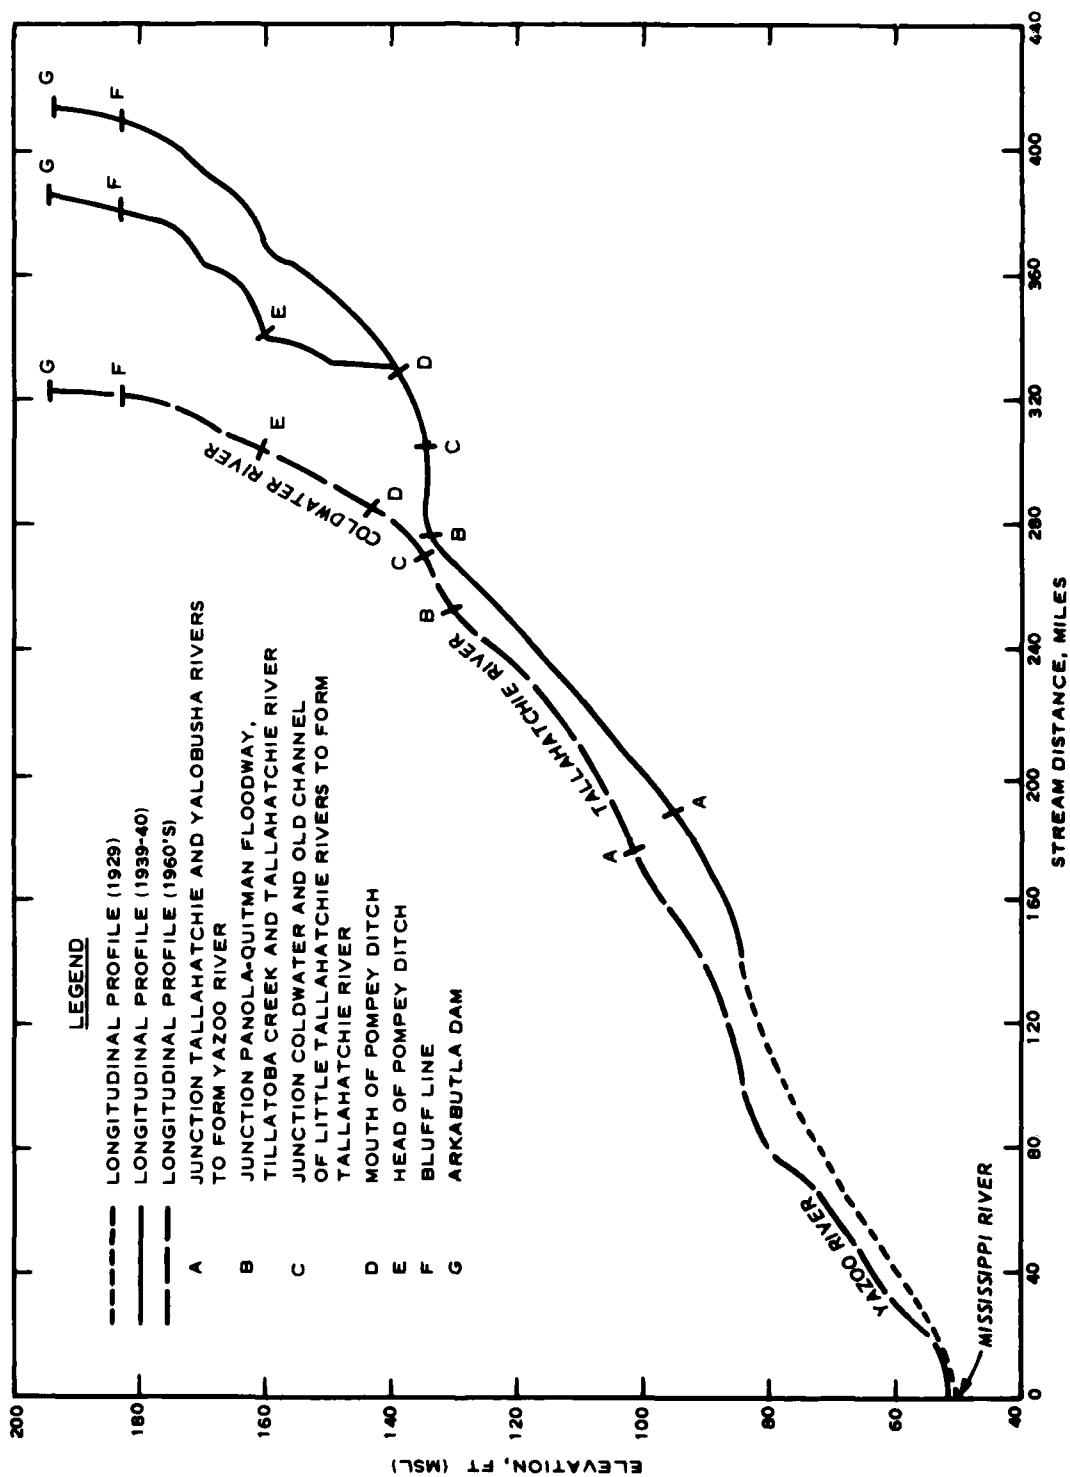
136. The prechannelization and postchannelization longitudinal profiles of the Yazoo-Tallahatchie-Coldwater River system are both very irregular (Figure 76). The irregularities can be attributed to several sources, such as degradation, geologic controls, and aggradation. The increased gradient of the Yazoo-Tallahatchie-Coldwater River system resulting from channelization, increased water discharge resulting from agricultural practices, and the instability of the Mississippi River are some of the factors that could have caused degradation in the Yazoo-Tallahatchie-Coldwater River channels.

Figure 76. Longitudinal profiles of the Yazoo-Tallahatchie-Coldwater River system (data from USGS topographic maps)

137. The prominent knickpoint at point B in Figure 76 resulted from geologic controls. The lateral extent of the geologic unit can easily be seen on the planview of this section of the river (Figure 77). The channel between elevation 140 and 125 is cutting in ancestral Mississippi River braided stream (Kolb et al. 1968) deposits veneered by clayey backswamp-type deposits. The veneer deposits consist of 10 to 30 ft of erosion-resistant oxidized clay, which grades downward into coarser braided stream materials. The channel in the erosion-resistant clay has a gentler slope and small, tight meanders. The channel above elevation 140 and below elevation 125 is cutting in point bar deposits consisting of sediments ranging from sandy clays to sandy silts (Kolb et al. 1968). The point bar deposits could be from any of the ancestral Mississippi River systems that have occupied that area. The channels in the more easily eroded point bar deposits have steeper slopes and large closed meanders. The effects of the geologic control can still be seen on the 1960's longitudinal profile even after the extensive channelization of this section of Tallahatchie River.

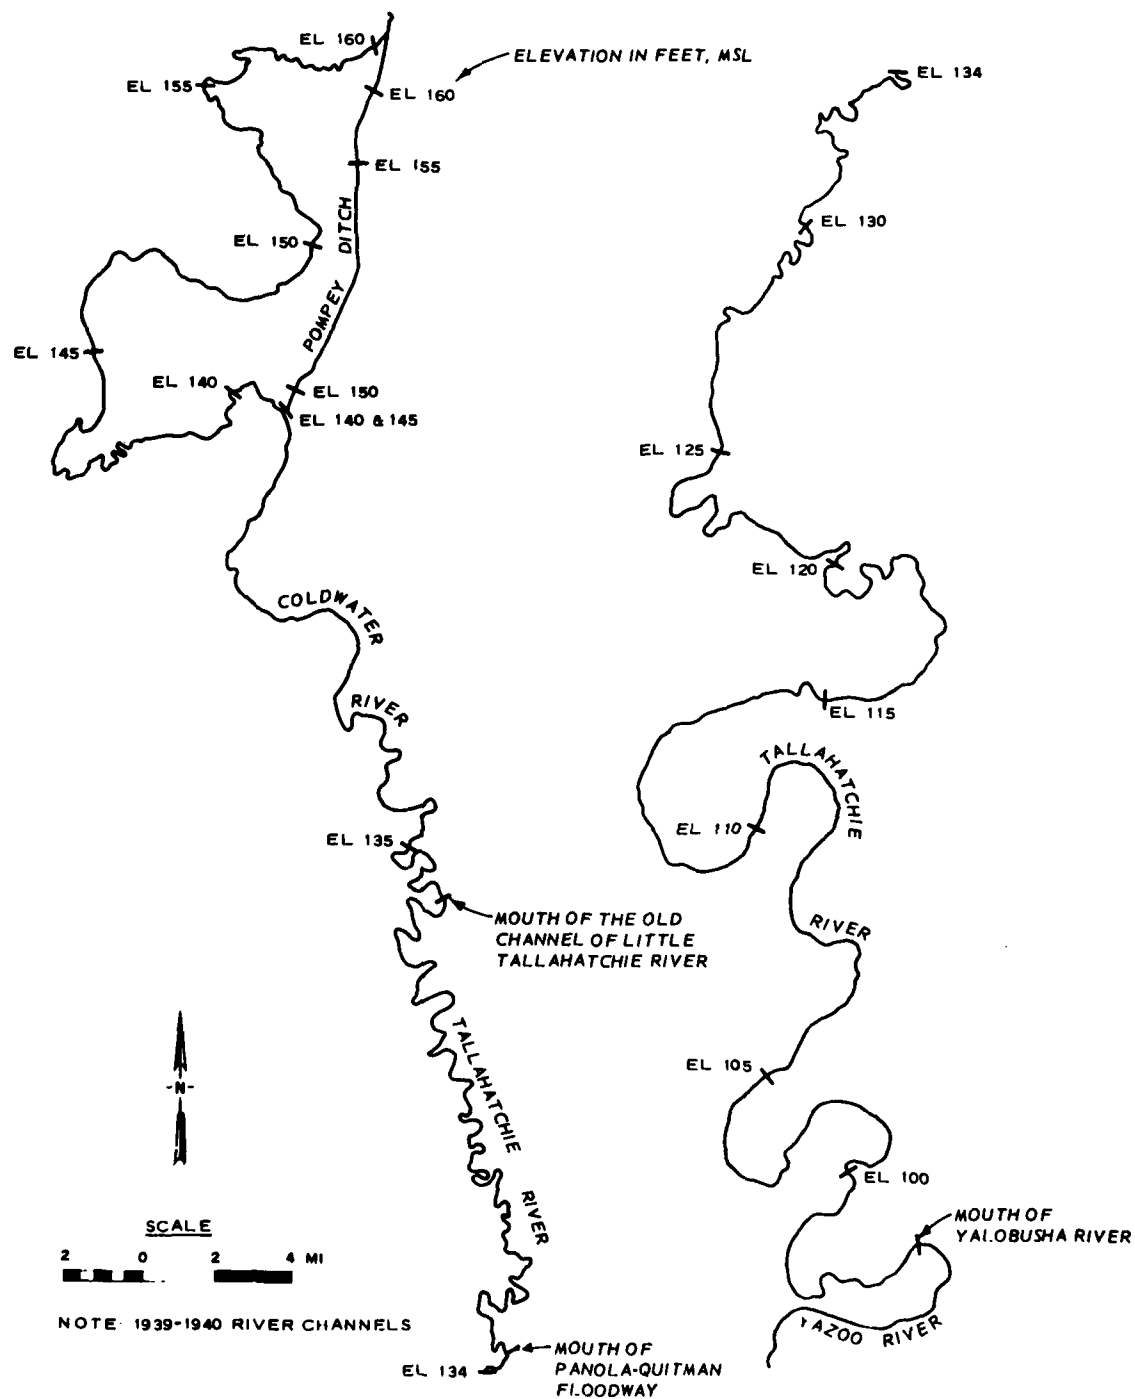
Figure 77. Change in meander pattern on the Tallahatchie River due to geologic control

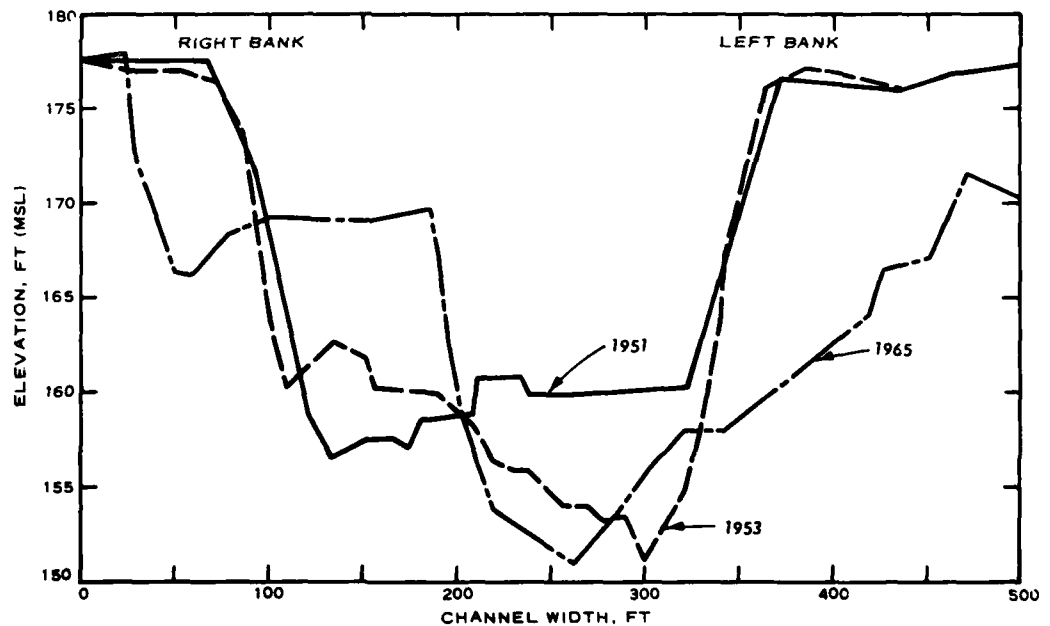
Figure 88. Cross sections of Yalobusha River directly downstream from the mouth of Batupan Bogue (U. S. Army Corps of Engineers 1966c)
